Manhole Inspection Summary

Manhole # S08YY1007MH

Insp Date: **6/30/06 7:53 AM**

Location Address: **4226 FALLSTAFF RD**

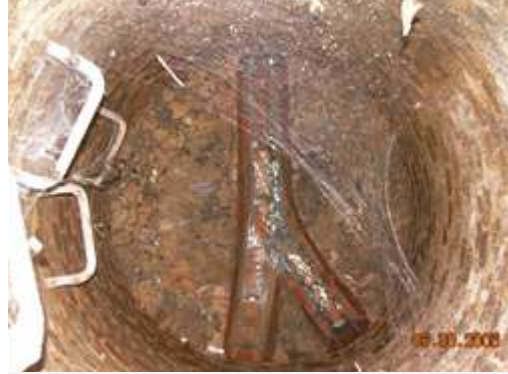
Top View

☒ **Debris** (not Condition related)

☒ **Evidence Of Surcharge**

Depth: **1.5** (ft.)

Evidence of surcharge - Bench debris.

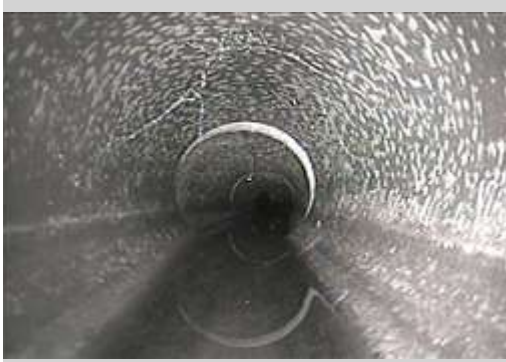
Inside the I5

Offset joint.

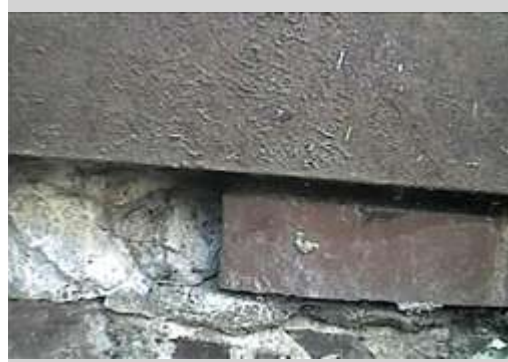
Defect

☒ **Leaks**

Condition: ☐ Sound ☐ Cracked ☐ Root Intrusion ☒ **Loose Brick** ☒ **Deteriorated**

Infiltration: ☐ None ☒ **Joint** ☐ Cracks ☒ **Mortar** ☐ Roots ☐ Wall

Frame leaks. Adjustment deterioration, loose brick and infiltration.

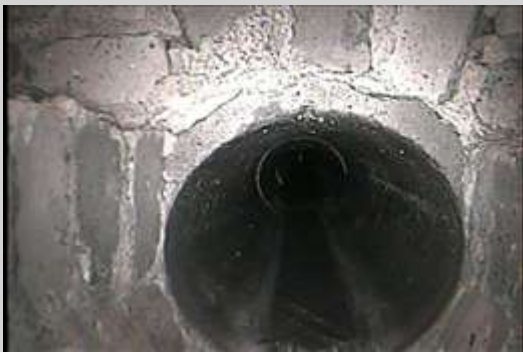
8 in. Circular Gravity Sewer Pipe Out @ 12 O'Clock

Barrel deterioration.

Infiltration: **None** Pipe Seal Cond: **Cracked**

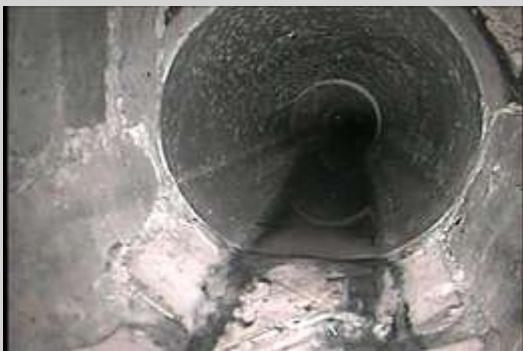
8 in. Circular Gravity Sewer Pipe In @ 5 O'Clock

Condition: ☐ Sound ☐ Cracked ☐ Root Intrusion ☒ **Deteriorated** ☐ Leaks ☐ Debris

Channel deterioration.

Infiltration: **Evidence** Pipe Seal Cond: **Unknown**

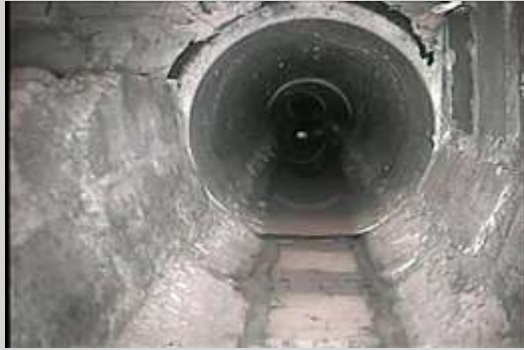
Pipe In @ 6 O'Clock

Deposits: ☐ None ☐ Mud ☐ Sludge ☐ Debris ☒ **Grease**

Deposits Extent: **Light**

Infiltration: **Evidence**

Pipe Seal Cond: **Cracked**
